F28M36x Concerto™ MCUs Silicon Errata

Silicon Revisions F, E, B, A, 0

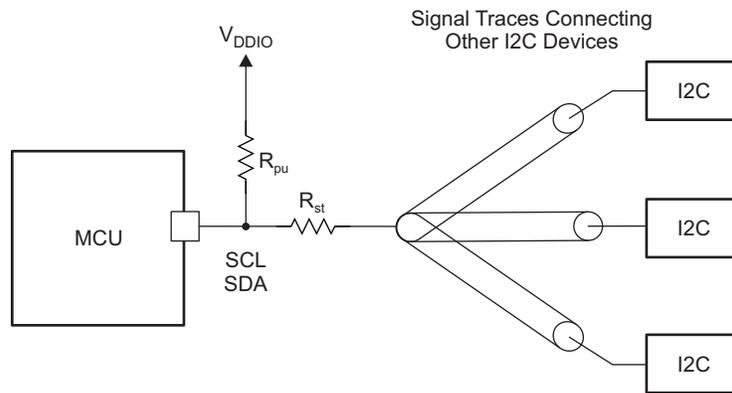
Figure 8. Placement of Series Termination Resistor and Pullup Resistor

The SDA and SCL outputs are implemented with push-pull 3-state output buffers rather than open-drain output buffers as required by I2C. While it is possible for the push-pull 3-state output buffers to behave as open-drain outputs, an internal timing skew issue causes the outputs to drive a logic-high for a duration of 0–5 ns before the outputs are disabled. The unexpected high-level pulse will only occur when the SCL or SDA outputs transition from a driven low state to a high-impedance state and there is sufficient internal timing skew on the respective I2C output.

This short high-level pulse injects energy in the I2C signals traces, which causes the I2C signals to sustain a period of ringing as a result of multiple transmission line reflections. This ringing should not cause an issue on the SDA signal because it only occurs at times when SDA is expected to be changing logic levels and the ringing will have time to damp before data is latched by the receiving device. The ringing may have enough amplitude to cross the SCL input buffer switching threshold several times during the first few nanoseconds of this ringing period, which may cause clock glitches. This ringing should not cause a problem if the amplitude is damped within the first 50 ns because I2C devices are required to filter their SCL inputs to remove clock glitches. Therefore, it is important to design the PCB signal traces to limit the duration of the ringing to less than 50 ns. One possible solution is to insert series termination resistors near the SCL and SDA terminals to attenuate transmission line reflections.

Insert series termination resistors on the SCL and SDA signals and locate them near the SCL and SDA terminals. The SCL and SDA pullup resistors should also be located near the SCL and SDA terminals. The placement of the series termination resistor and pullup resistor should be connected as shown in [Figure 8](#).
