# PIC32MK GPK/MCM Family

## PIC32MK General Purpose and Motor Control (GPK/MCM) with CAN FD Family Silicon Errata and Data Sheet Clarifications

### PIC32MK GPK/MCM with CAN FD Family Errata

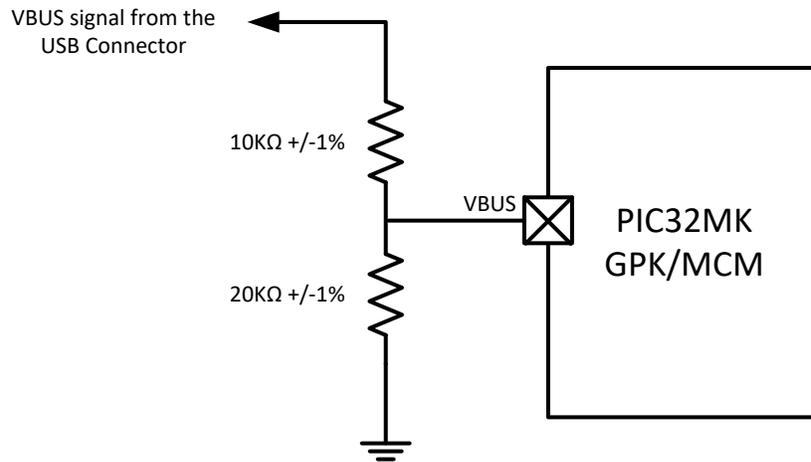
### 2.2.2 VBUS pin

The VBUS pin is not 5V tolerant.

Connect an external voltage divider as shown in the following figure:
