This errata sheet provides updated information about known device issues affecting Arria® II GX devices.

EDCRC False Error

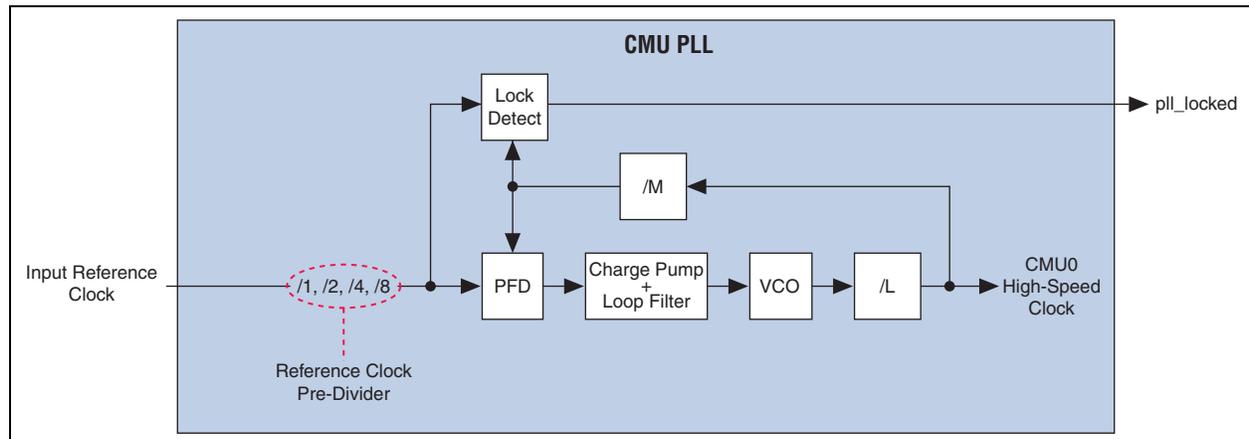
Figure 1. Reference Clock Pre-Dividers in Transmitter PLLs

The transmitter phase-locked loop (PLL) lock status signal (pll_locked) does not de-assert when the pll_powerdown signal is asserted in configurations that use the reference clock pre-divider of 2, 4, or 8. [Figure 1](#) shows the reference clock pre-divider inside transmitter PLLs. This issue impacts the pll_locked status signal in the clock multiplier unit (CMU) PLL.

Designs that implement the recommended transceiver reset sequence described in the *Reset Control and Power Down in Arria II Devices* chapter in volume 2 of the *Arria II Device Handbook* could potentially see a link failure after coming out of reset.

If the pll_locked issue impacts your design, instantiate and connect the pll_locked_soft_logic module, as shown in **Figure 3**. You must use the pll_locked_to_corelogic output from this module in the transceiver reset logic and any user logic that relies on the transmitter PLL lock status signal.

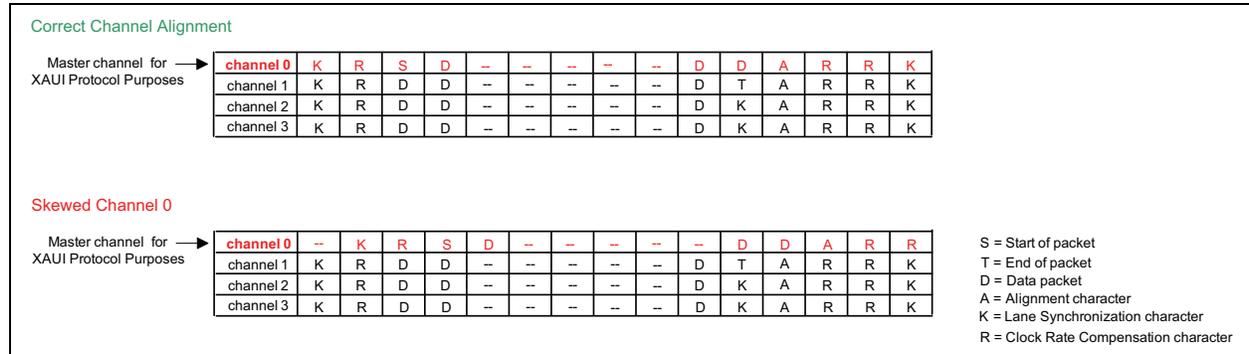
Figure 4. Rate Matcher FIFO Skew

In XAUI functional mode, the data out of the channel 0 Rate Match FIFO may be shifted by one byte with respect to the data of the other three channels. This causes incorrect idle ordered set conversion, resulting in incorrect received parallel data. This issue happens only during initialization or receiver channel reset (assertion of `rx_analogreset` or `rx_digitalreset`).

Figure 4 shows the channel skew.

Altera provides a soft IP solution and associated documentation, available for download at: www.altera.com/patches/xau-softip/xau-softip-fix-reva.zip. This soft IP should be integrated into the XAUI receiver data path. This issue is fixed in production devices.
