ES_LPC3250 Errata sheet LPC3250 Rev. 9 — 1 June 2011

Info	Content
Keywords	LPC3250 errata
Abstract	This errata sheet describes both the known functional problems and any deviations from the electrical specifications known at the release date of this document.
	Each deviation is assigned a number and its history is tracked in a table.

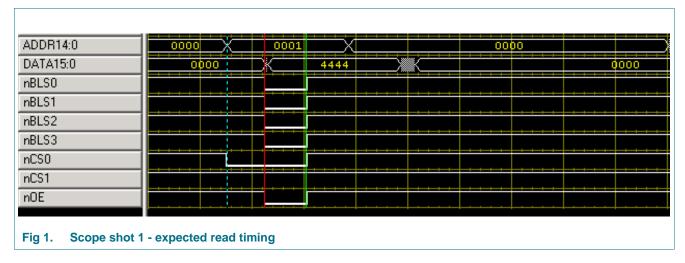
When using memory-to-memory DMA with the EMC static chip select (EMC_CS[x]_N) as the DMA source and the DMA channel source burst size is set for a single transfer (DMACCxControl:SBSIZE = 0), each DMA source read should be a single bus-wide access. The access should be similar to reading the EMC_CS[x]_N static memory with an ARM LDR instruction, as shown in Figure 1. Note the EMC signal timing for the read is controlled by the EMCSTATICx registers. In all example scope shots the EMCSTATICWAITx registers are set to the maximum value.

- 1. Avoid using DMA to transfer read blocks of data from the external device. Instead use a software loop with LDR instruction to read blocks of data from the external device.
- 2. If DMA can't be avoided, ensure there is at least one unused address between the highest address used for the external device DMA data buffer and any status or control register in the device that will initiate any unwanted action just by reading from the register (i.e. clear an interrupt or status).

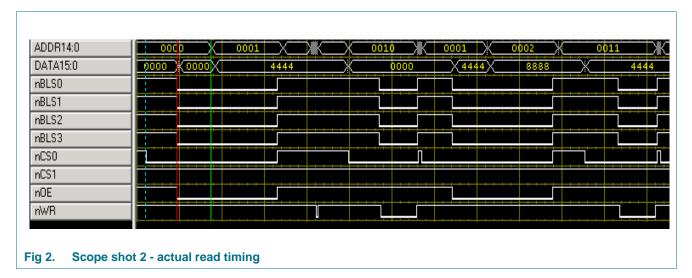
DMA register values used in Figure 2:

However, the actual EMC timing for the source DMA read is a double wide chip select with a burst of two reads (notice how the address increments near the halfway point of nCS0 active), see Figure 2. The second data read during the burst is discarded, as the DMA destination write (also to nCS0 in Figure 2) following each read, always writes the first value read during the read burst. When the DMA source address is set to auto-increment, the last DMA read transfer will address the last address of the source buffer and the last source buffer address +1. This behavior only happens during the read part of the DMA transfer. Memory-to-memory DMA destination writes to the EMC static chip select work as expected.

- DMA reads from an external memory will have lower performance than a software read loop. The source read burst of two, to get one transfer, will significantly increase the time to complete all transfers in the memory-to-memory DMA, therefore decreasing the overall throughput possible on the EMC_CSx_N static memory interface.
- Potential unintended consequence when the last DMA read accesses the address beyond the DMA source buffer address in the FPGA or external peripheral chip. This extra address is the second access during the last DMA source read.

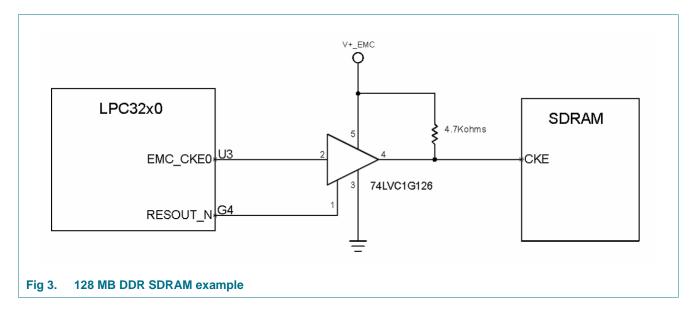
If the LPC3250 is reset during an SDRAM access, the SDRAM clock and clock enable will be immediately de-asserted. If the de-assertion occurs during the period of time the SDRAM is driving the data bus, the SDRAM will hold that state until the next clock occurs at the SDRAM clock input when the clock enable is active. However, the LPC3250 won't deliver the clock and clock enables until software actually sets up the EMC state to do this, so the SDRAM will remain in the data assertion state on the data bus while the LPC3250 tries to boot.

When the chip attempts to load boot code from NOR FLASH after reset, the correct signals are asserted to the NOR FLASH device and the NOR FLASH device places its data on the data bus. But if the SDRAM is still driving the bus, the NOR FLASH device and SDRAM device are in contention and the data will not be read correctly into the LPC3250. In this situation, the LPC3250 will fail to boot.

If booting from NOR FLASH is a requirement, the simple circuit shown in Figure 3 can be used to clear the SDRAM state at system reset. This will not change the normal functioning of the LPC3250 EMC or SDRAM operations. If SDRAM devices are also present on the 2nd SDRAM chip select, a similar circuit will be needed for those devices using EMC_CKE1.

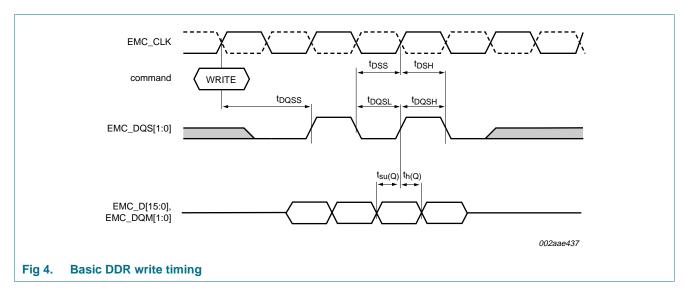
DDR memory interface signal EMC_DQS[1:0] is source synchronous, defined to be driven by the MCU center aligned to the data EMC_D[15:0] for writes, while driven by the DDR memory edge aligned to the EMC_D[15:0] for reads. The basic DDR write timing is shown in the data sheet Fig 1.

For DDR writes the LPC3250 drives the EMC_DQS[1:0] earlier in the data valid window than center aligned. With the EMC_CLK at 133 MHz this produces a minimum set-up time between the EMC_D[15:0] and EMC_DQS[1:0] of 600 ps across silicon process, voltage and temperature. Test conditions are with the EMC buffers set to fast slew rate driving 2 inches of 50 Ω transmission line and 10 pF load capacitance. DDR memories specify EMC_D[15:0] to EMC_DQS[1:0] set-up time minimum as 400 ps. This leaves 200 ps set-up time margin due to customer specific load and PCB layout implementation. See the LPC3220_30_40_50 data sheet for the complete range of DDR data output set-up time, $t_{\text{Su}(Q)}$, and data output hold time $t_{\text{h}(Q)}$ times.
