Introduction

Thank you for designing with the Xilinx Virtex®-6 family of devices. Although Xilinx has made every effort to ensure the highest possible quality, the devices listed in [Table 1](#) are subject to the limitations described in the following errata.

Table 1: Devices Affected by These Errata

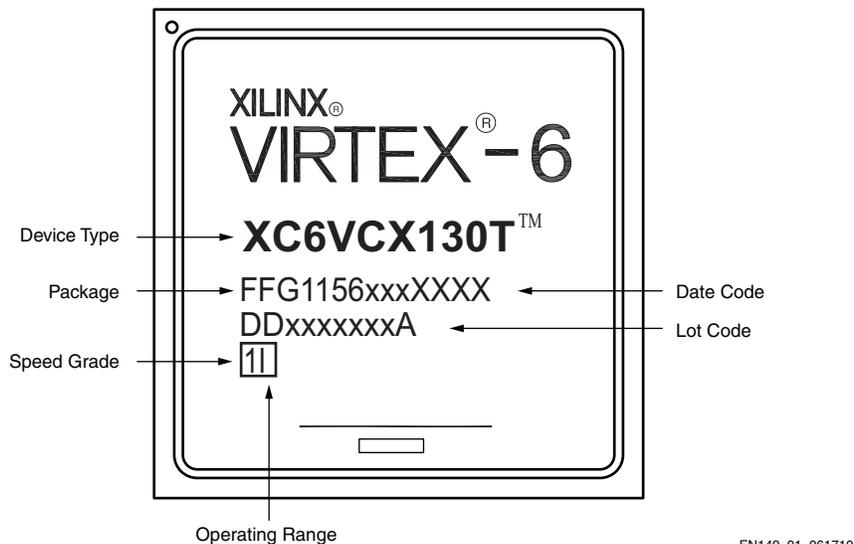
Figure 1: Example Device Top Mark

The XC6VCX130T is marked as shown in [Figure 1](#). The other devices listed in [Table 1](#) are marked similarly.
