# KK® 396 Cosmetic Deviation

07/07/14

# Description of Notification

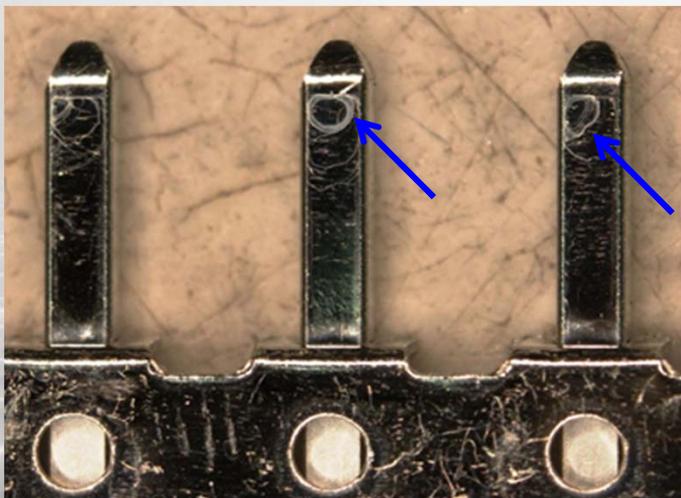
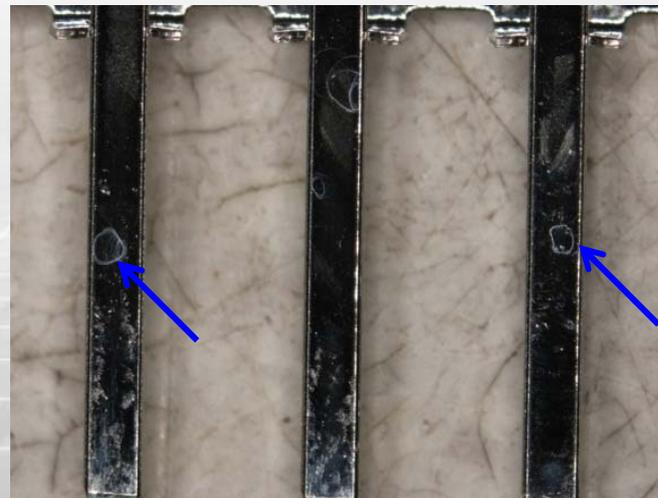
- › Starting the week of July 7<sup>th</sup>, customers purchasing from the attached list of KK® 396 family headers may see spots on the header pins
- › The spots have been tested by Molex Quality and have been confirmed to be cosmetic in nature. The spots **WILL NOT** affect form, fit or function of the headers

*Examples of discoloration spots, enlarged*

- › Molex's internal deviation was created to use headers as is, to prevent shipment interruptions: deviation per section 6.7 of Molex Cosmetic Specification document number PS-45499-002 (attached)
- › Molex quality engineers have determined the parts with the spots are functional to Molex's product specifications
- › Please do not enter quality notifications in relation to this issue
- › Additional quality/testing data is available upon request
- › If you or your customers have any questions, please contact your Molex sales representative.
